STRENGTHENING OF KEYED LONGITUDINAL CONSTRUCTION
JOINTS IN RIGID PAVEMENTS

ARMY ENGINEER WATERWAYS EXPERIMENT STATION

AUGUST 1972

Report No. FAA-RD-72-106

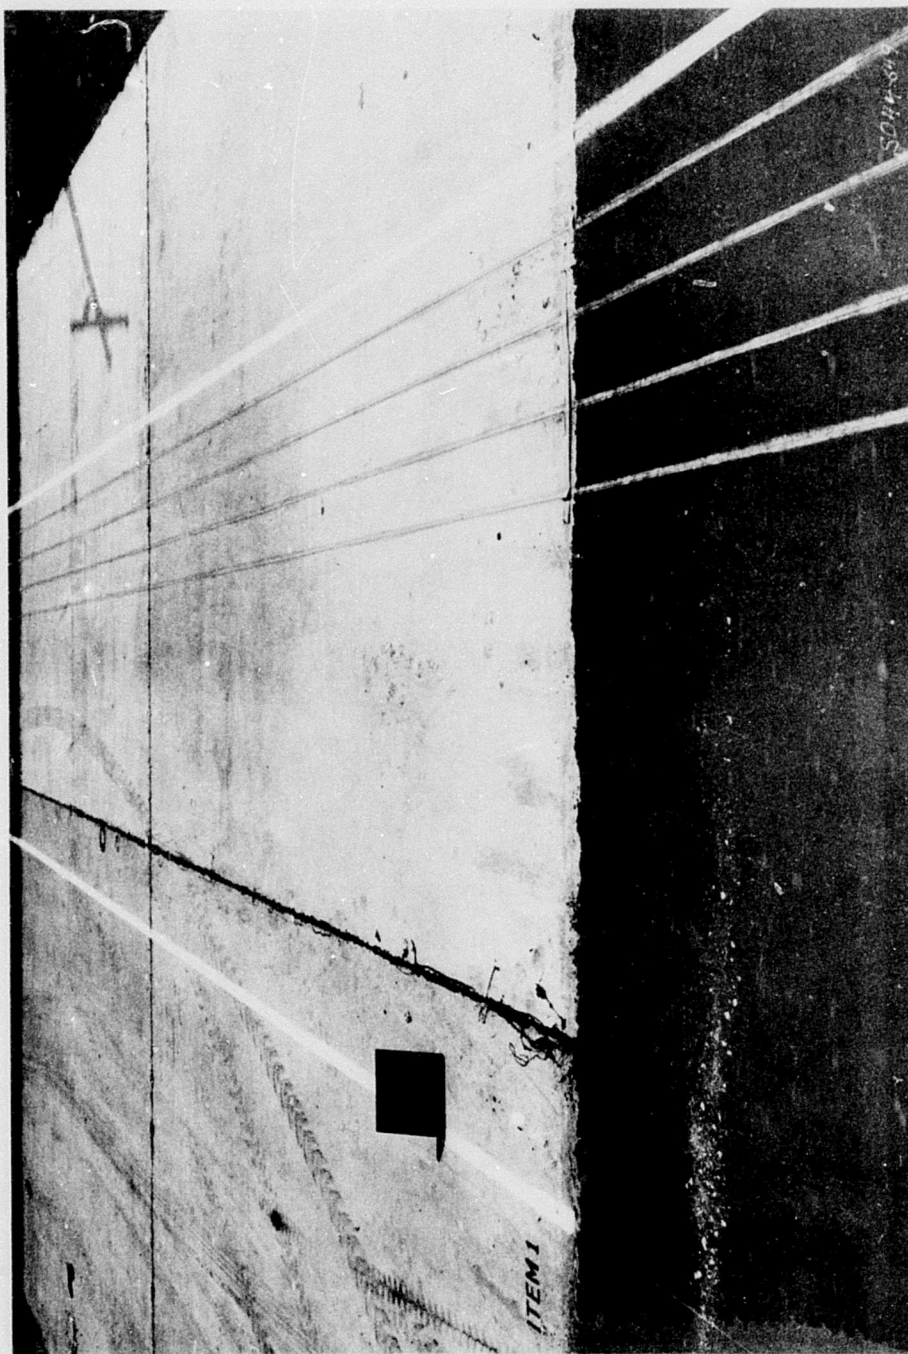
A general view of test item 1 prior to traffic is shown in figure 27. As can be seen in this photograph, both the southwest and northwest slabs contained longitudinal cracks prior to traffic. The crack in the southwest slab began at the west end of the item about 9 ft from the south free edge and ran approximately 13 ft longitudinally into the slab. The crack in the northwest slab began at the west edge of the item and ran 21 ft longitudinally through the center of the slab. Neither of these cracks was located inside the 200-in.-wide traffic lane.

Figure 27. General view of item 1 prior to test traffic.

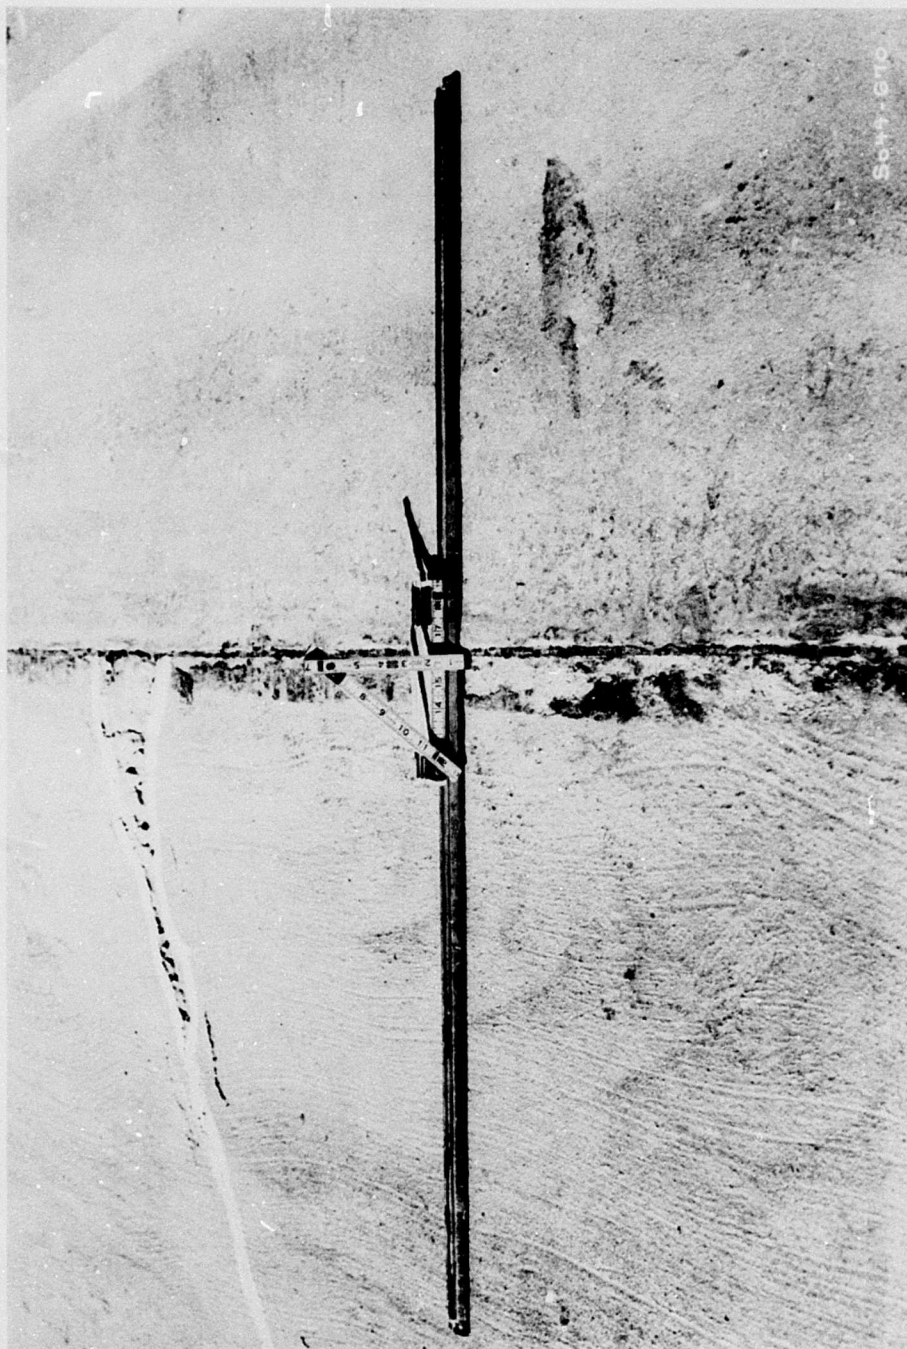
of the item. Additional surface cracking had developed in both of the north slabs and in the southwest slab after 504 coverages. Figure 29 depicts the crack pattern in this item after 504 coverages. Several of the cracks in the southwest slab were severely spalled and raveled. Traffic was stopped after 43 traffic patterns (688 coverages) due to the severe faulting of the keyed longitudinal construction joint, as well as the shattered-slab failures of both south slabs and the item was rated as failed. Figure 30 indicates faulting of $3/8$ to $1/2$ in. after 688 coverages at the construction joint between the southwest and northwest slabs. An overall view of the item after 688 coverages is shown in figure 31; the progression and extent of cracking due to test traffic is shown in figure 32. After traffic was discontinued, a portion of the southwest slab adjacent to the keyed construction joint was removed to confirm the joint failure. As can be seen in figure 33, the bottom half of the keyway of the keyed longitudinal construction joint was failed. The longitudinal construction joint containing the dowel bars on 12-in. centers in the eastern half of the item was in satisfactory condition at the end of traffic.

Figure 30. Faulting of longitudinal construction joint in item 1 after 688 coverages.

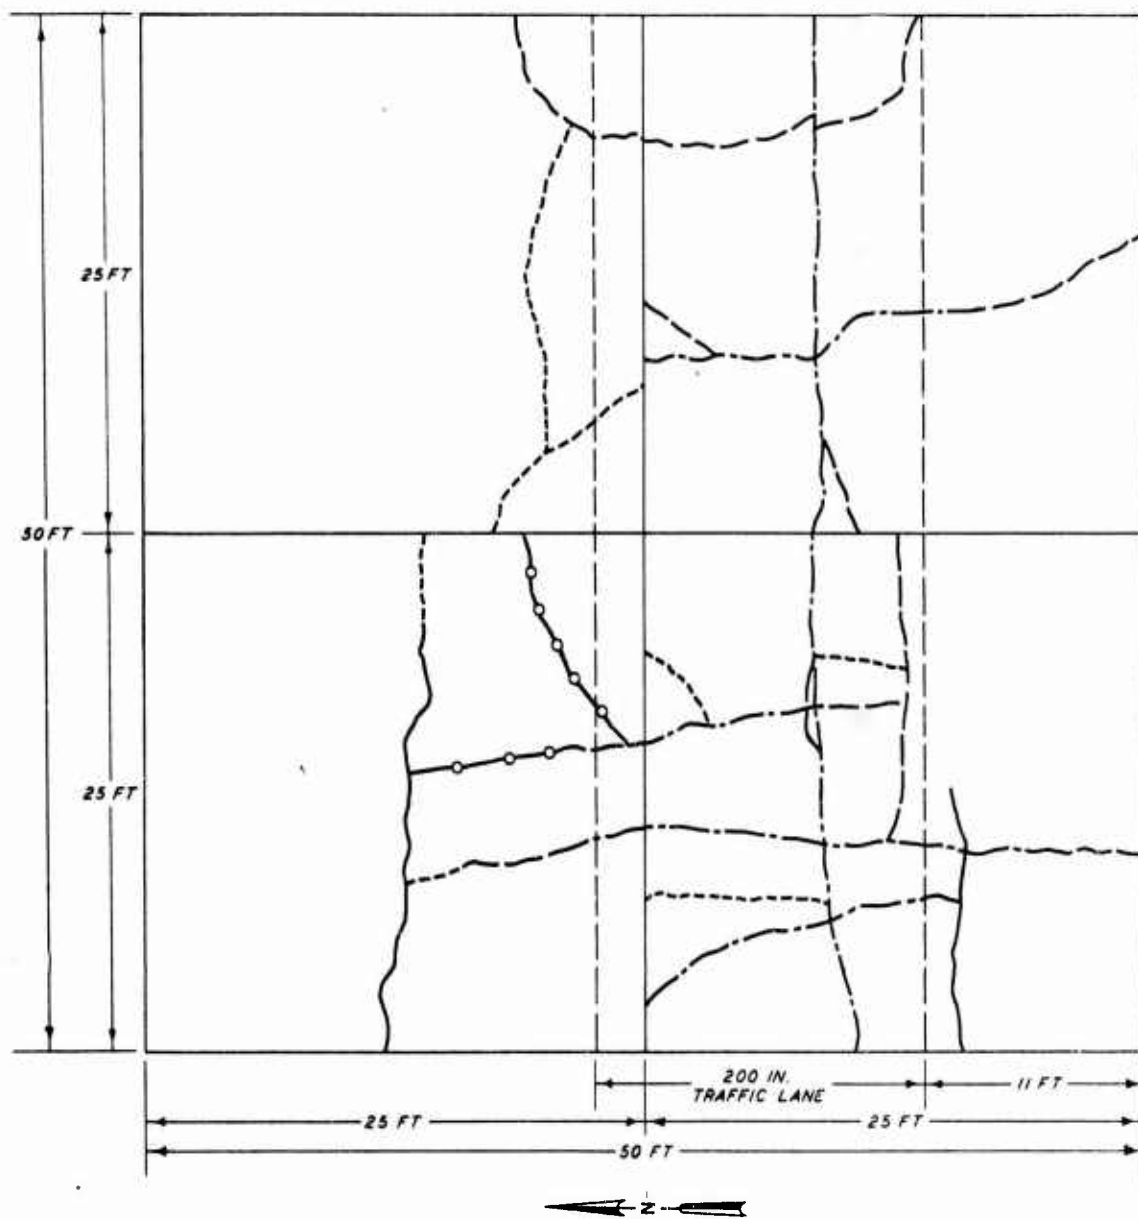
Figure 32. Crack development in item 1 under 360-kip, 12-wheel-assembly traffic.

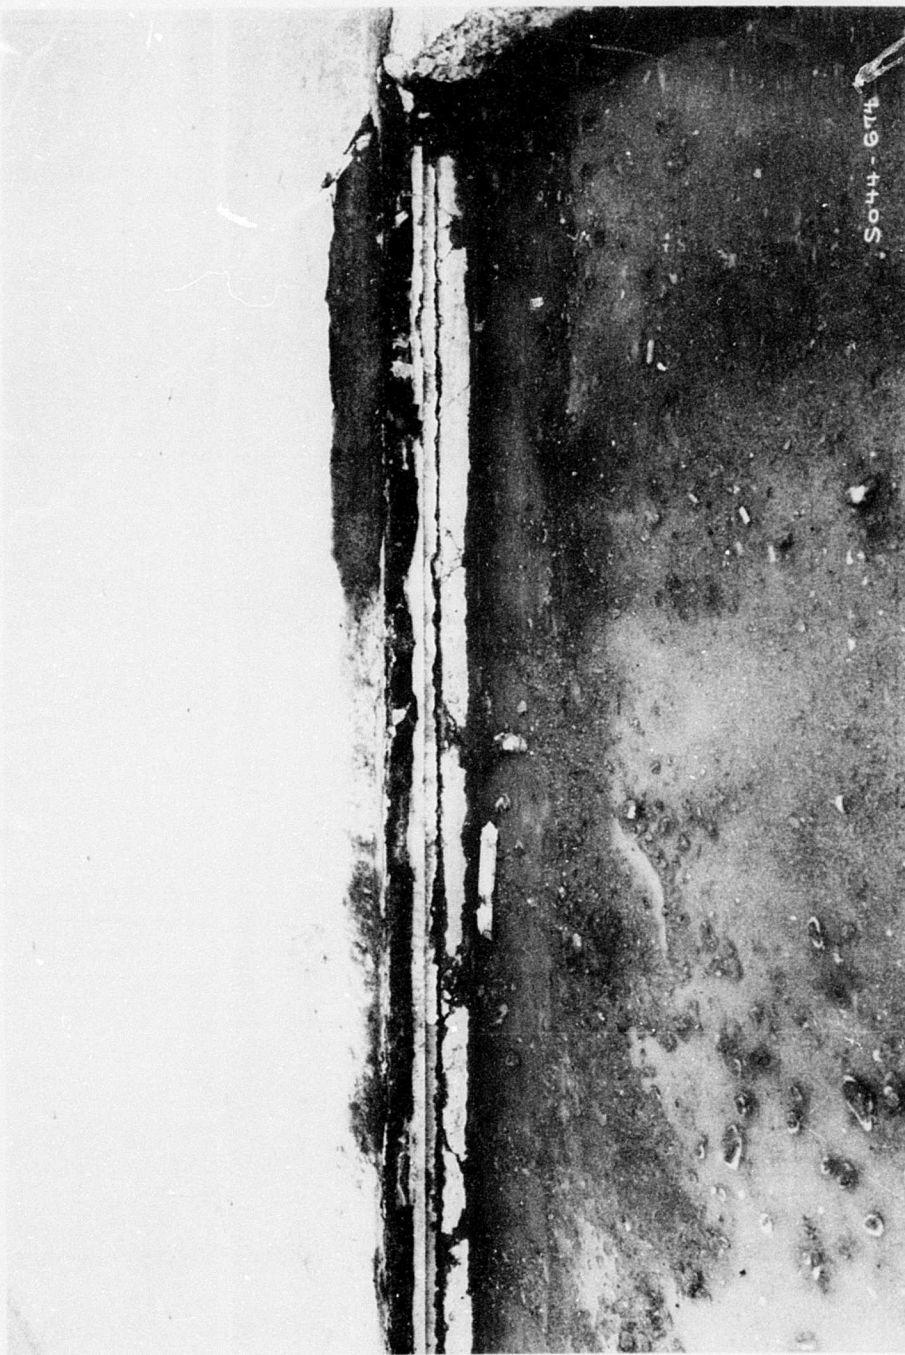
Figure 33. View of failed keyed longitudinal joint in item 1 after 688 coverages of the 360-kip, 12-wheel assembly.

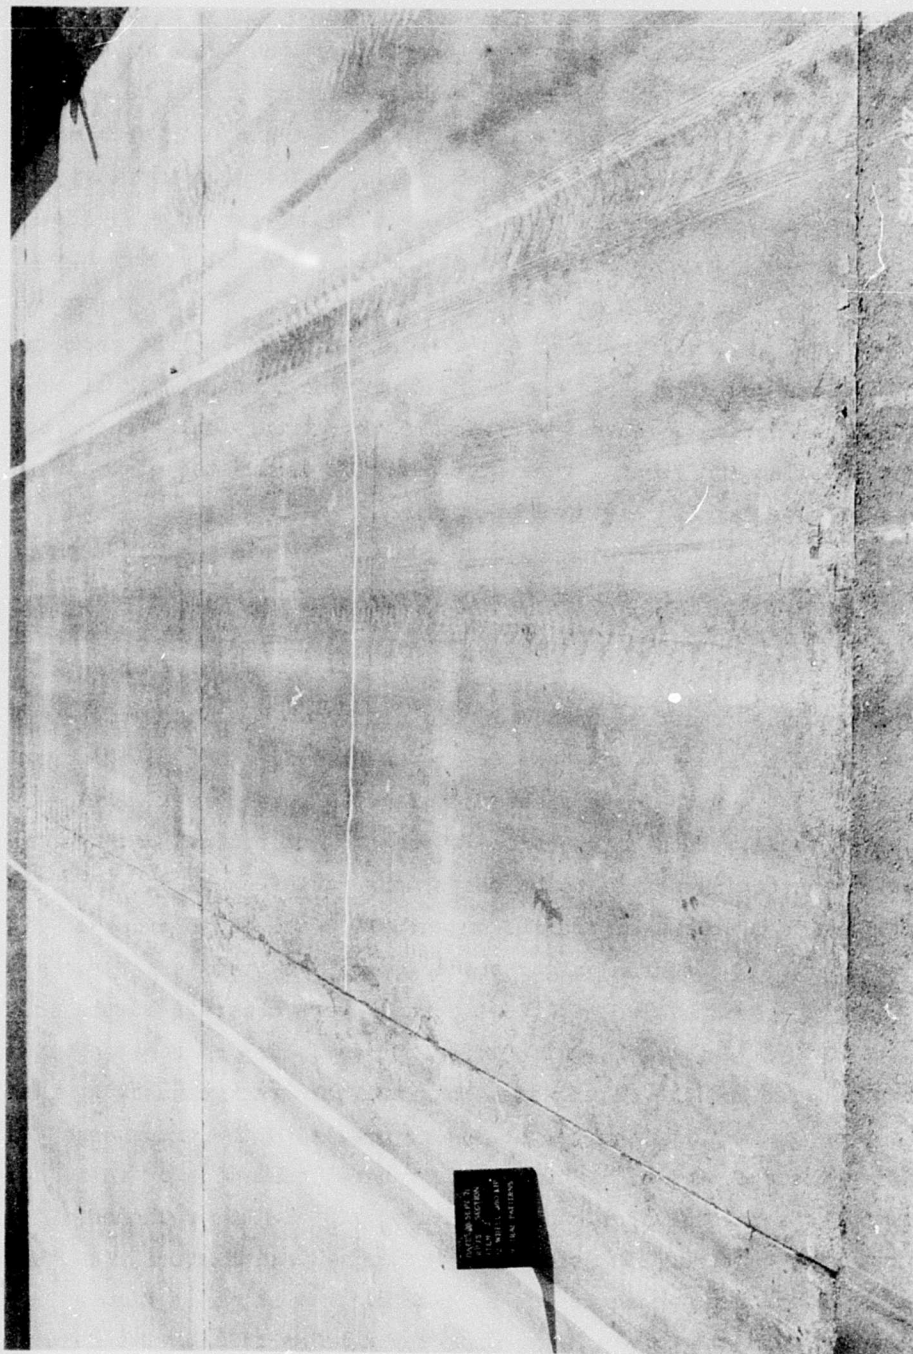
Initial cracking occurred during the ninth traffic pattern (144 coverages). This consisted of a transverse crack, which began at the longitudinal construction joint and ran about 15 ft across the southwest slab, as shown in figure 36. After 21.5 traffic patterns (344 coverages), the transverse crack in the southwest slab had progressed across the slab and a transverse crack was also detected going across the southeast slab. Both south slabs in this item were essentially halved by these cracks. Each of the three types of longitudinal construction joint strengthening seemed to be performing satisfactory at this time. After 10 more patterns of traffic or a total of 31.5 patterns, a slight amount of flaking occurred along the edges of the transverse cracks in the two south slabs. Two additional cracks were observed in the southeast slab at the 504 coverage level (31.5 patterns). One of these cracks was a corner break and the other was a longitudinal crack connecting the transverse crack that occurred at 344 coverages to the transverse weakened-plane contraction joint. The general condition of this item after 504 coverages is depicted in figure 37. The strengthened longitudinal construction joint was performing satisfactorily at this time; however, flaking and spalling such as that shown in figure 38 had occurred around all of the 8-in.-diam cored holes filled with sanded grout.

Figure 36. Initial crack in item 2, 360-kip, 12-wheel-assembly lane after 144 coverages.

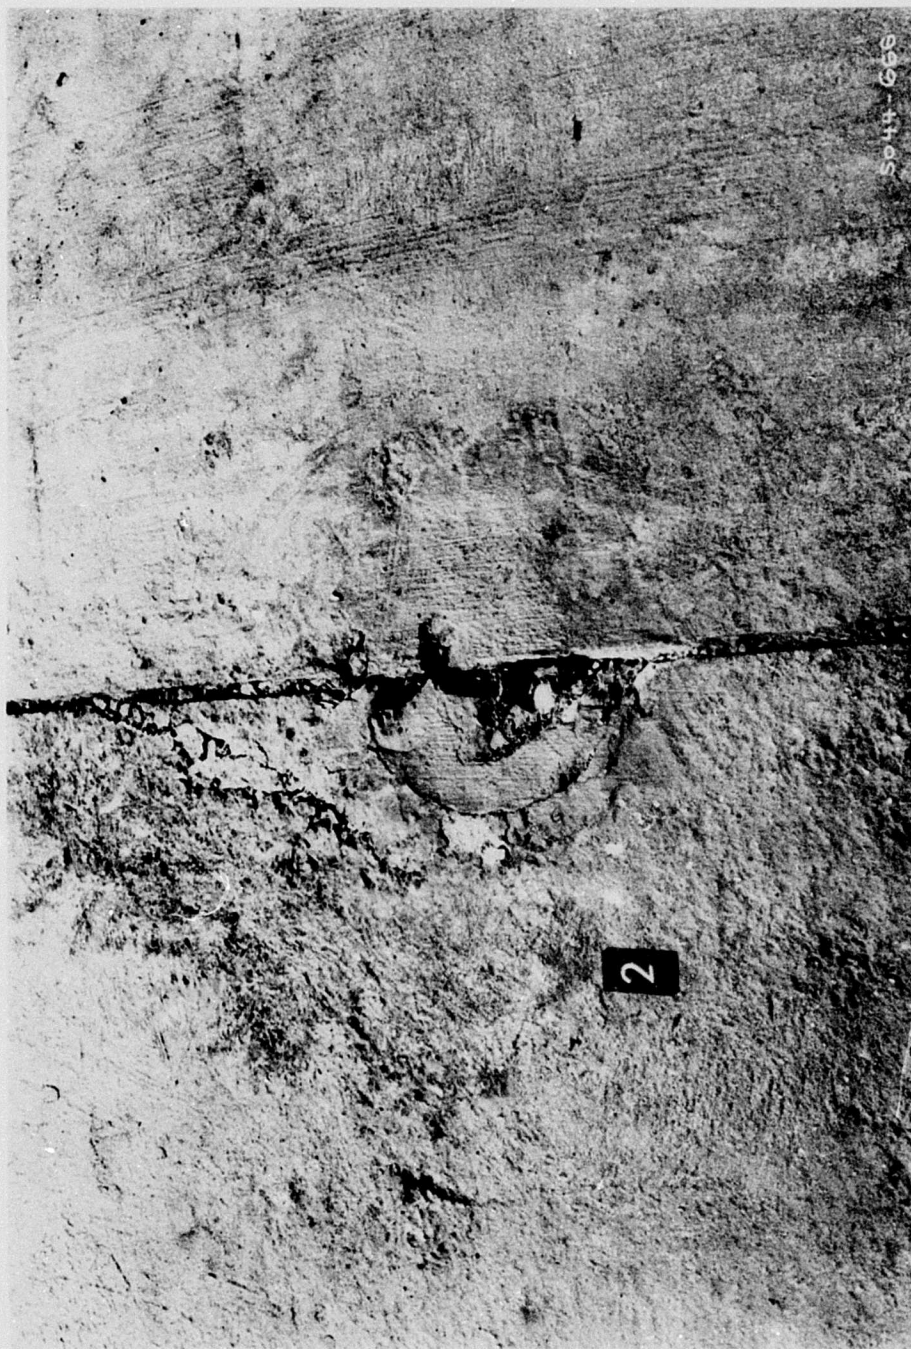
Figure 38. Flaking and spalling around the 8-in.-diam access holes filled with sand-cement grout (after 504 coverages).

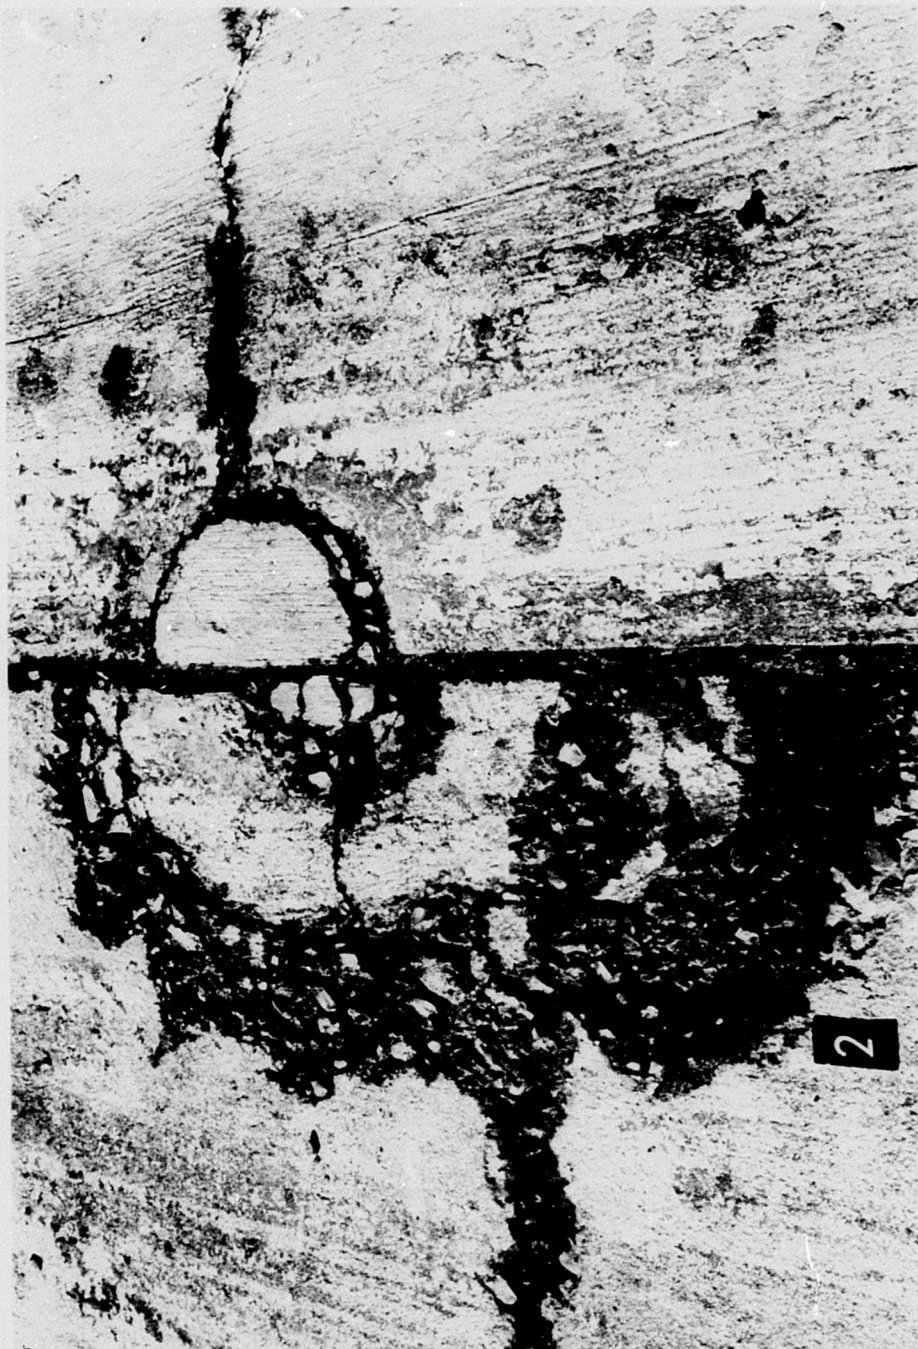
Figure 40. View of under-grouted joint in item 2, 360-kip, 12-wheel-assembly lane after 816 coverages.

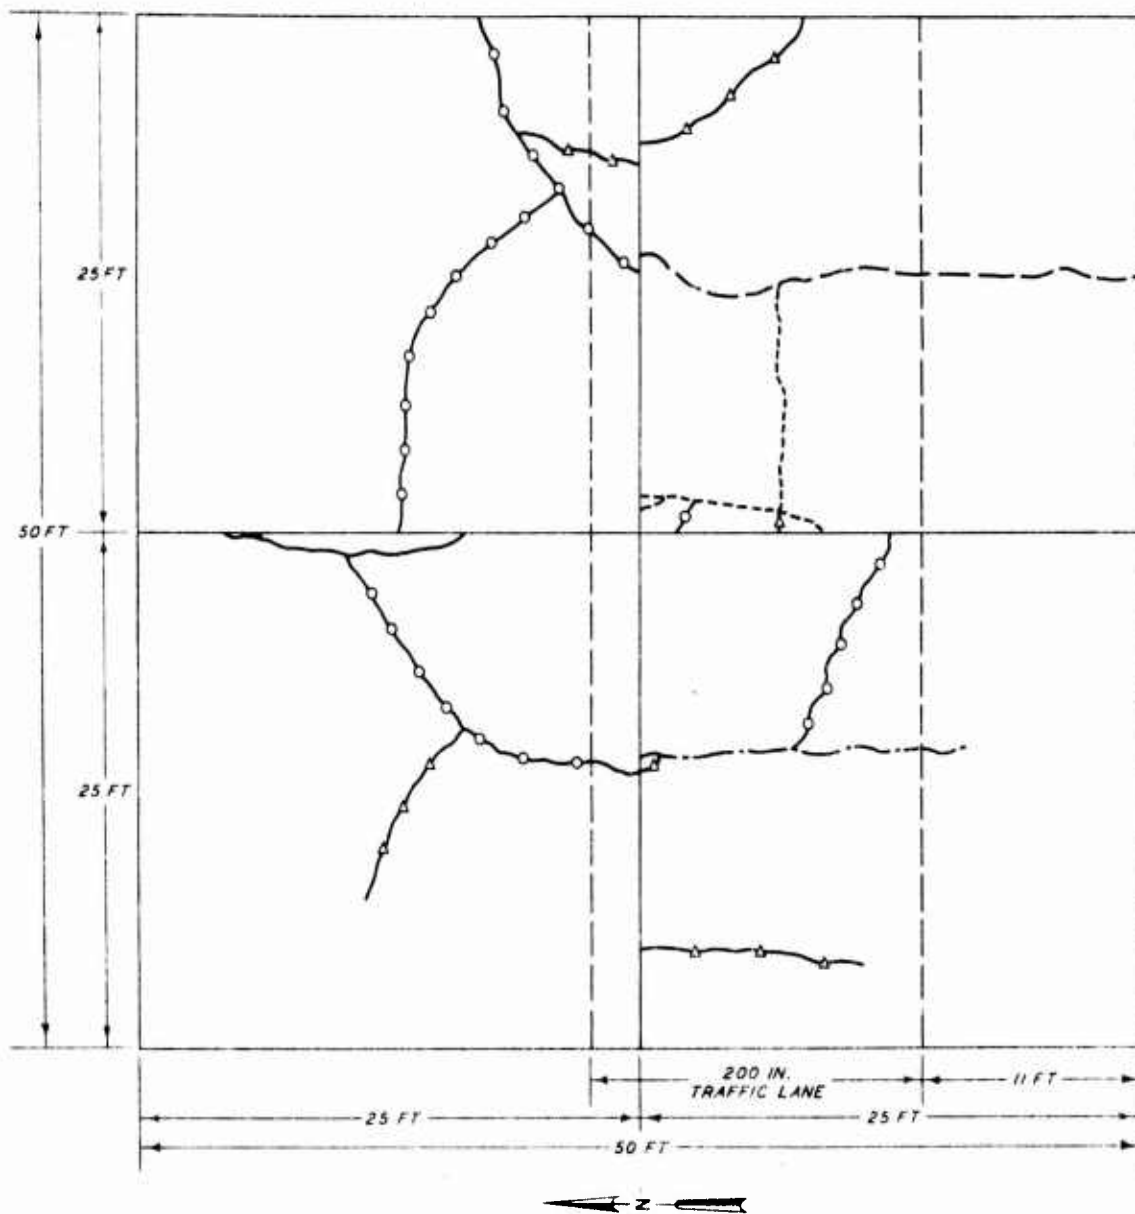
Figure 42. Crack development in item 2 under 360-kip, 12-wheel-assembly traffic.

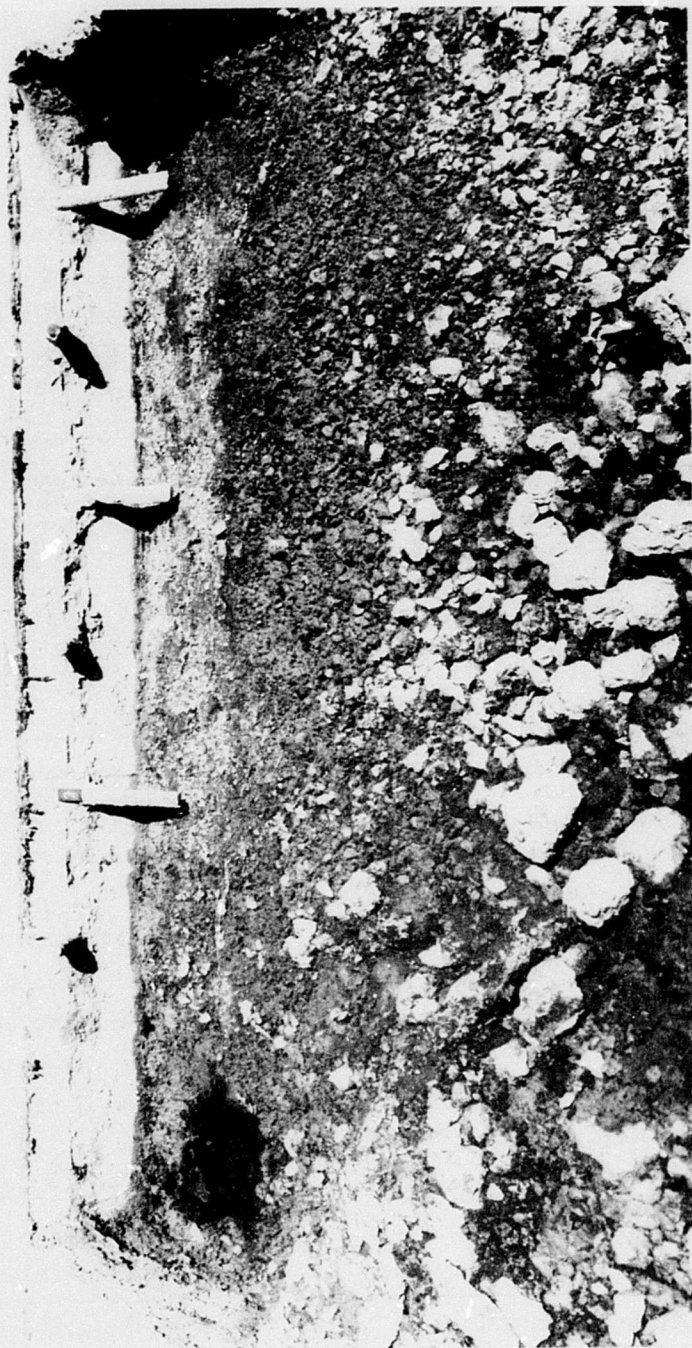
Figure 44. View of the longitudinal construction joint in item 2 strengthened by bonding bars at 45° angles (after 1676 coverages).

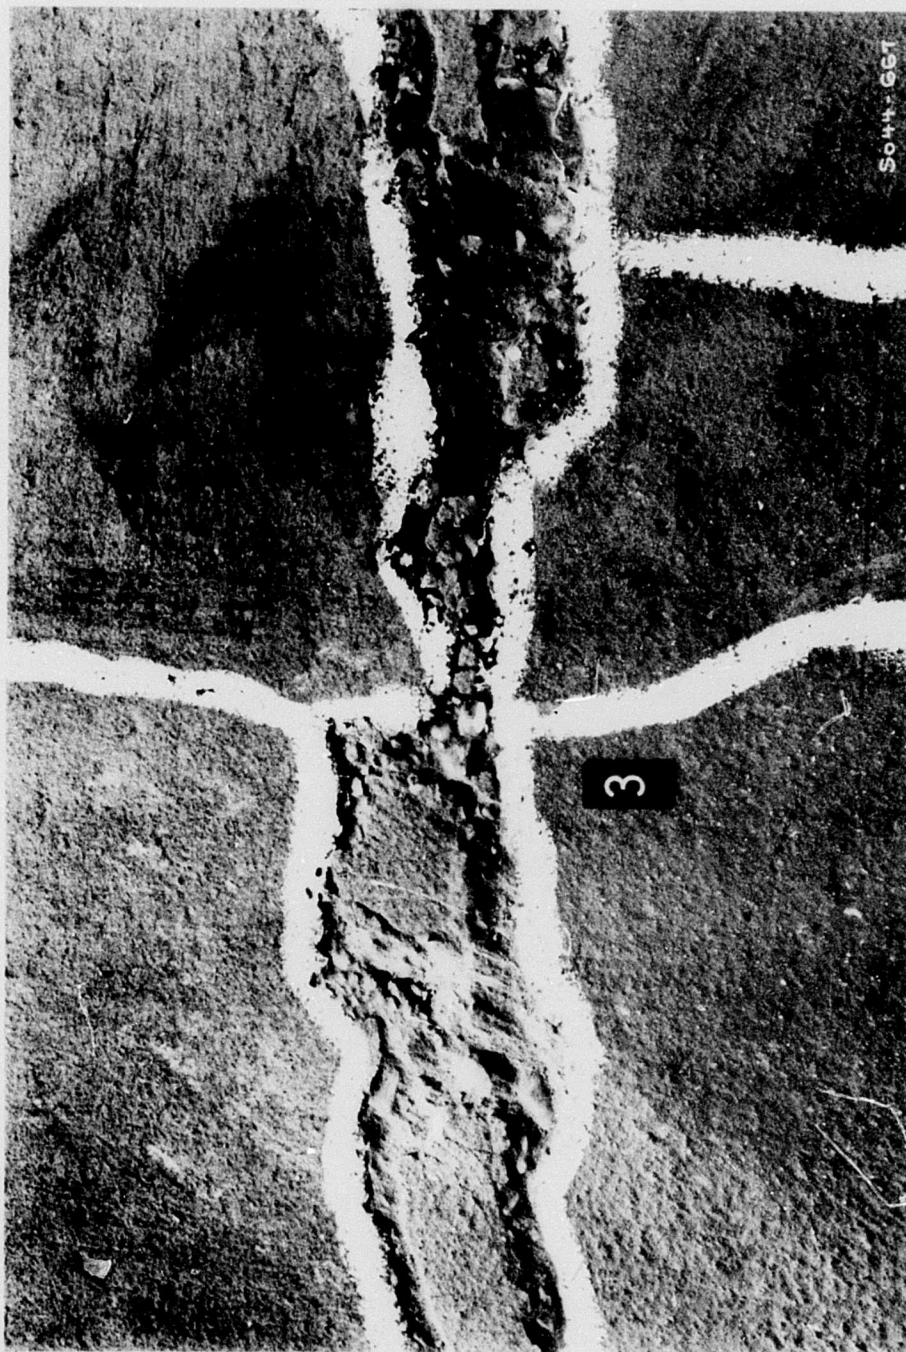
Figure 49. Spalling and flaking along cracks in item 3, 360-kip, 12-wheel-assembly lane after 504 coverages.

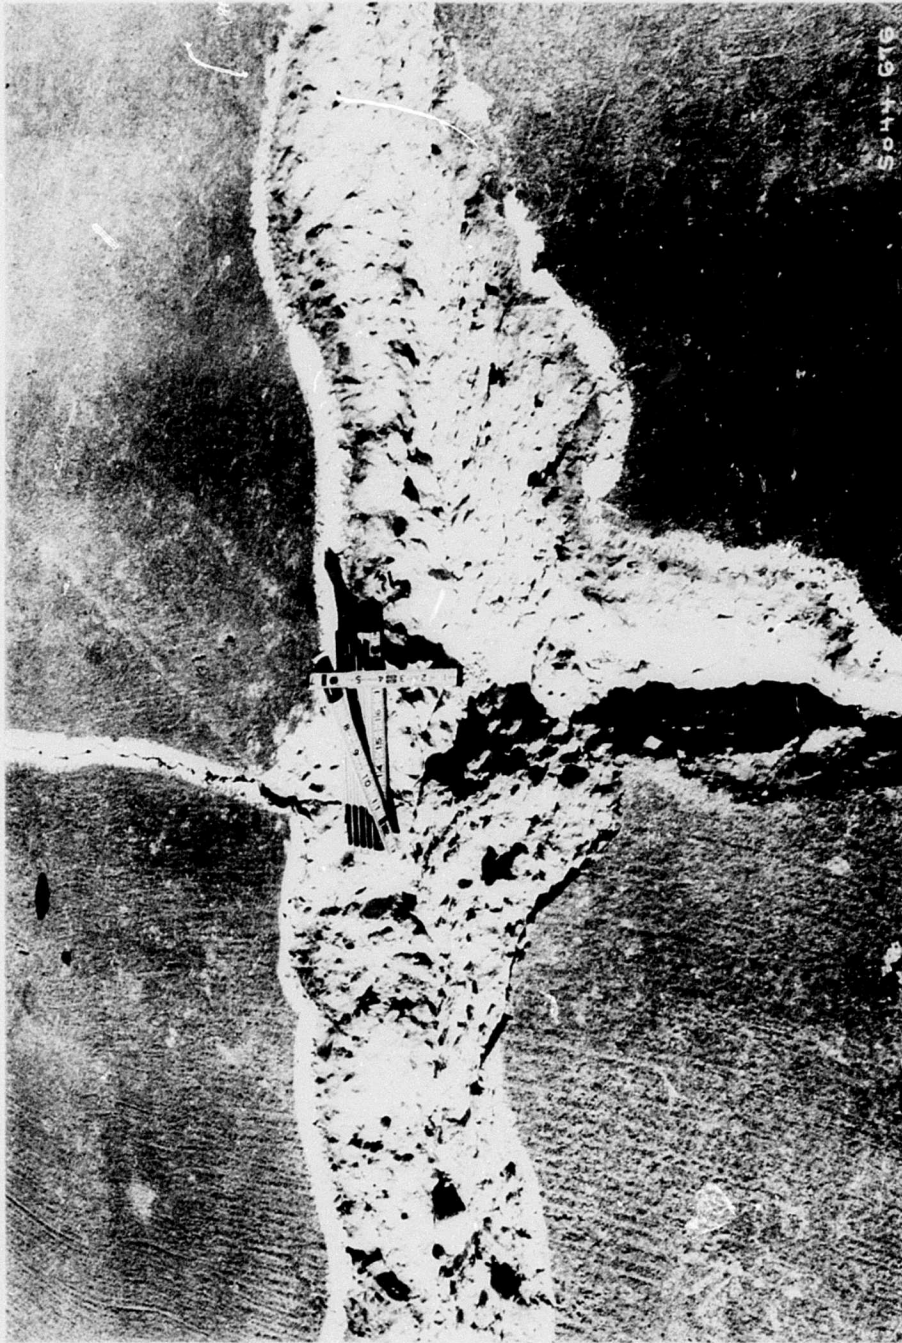
Figure 51. Typical spalled area in item 3, 360-kip, 12-wheel-assembly lane after 688 coverages.

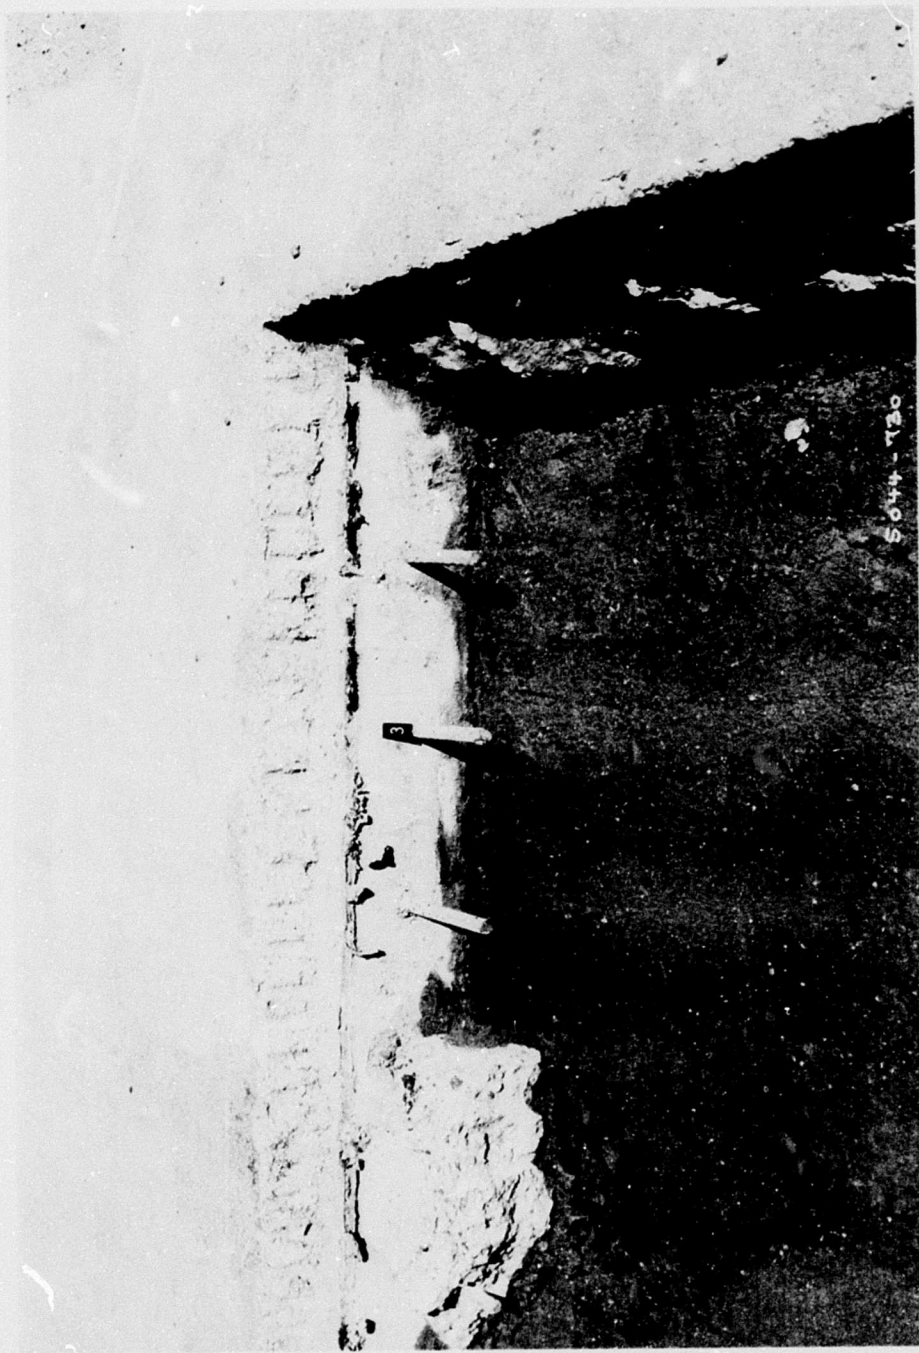
Figure 53. View of doweled longitudinal construction joint in item 3, 360-kip, 12-wheel-assembly lane after 688 coverages prior to overlaying and 5008 coverages after overlaying.

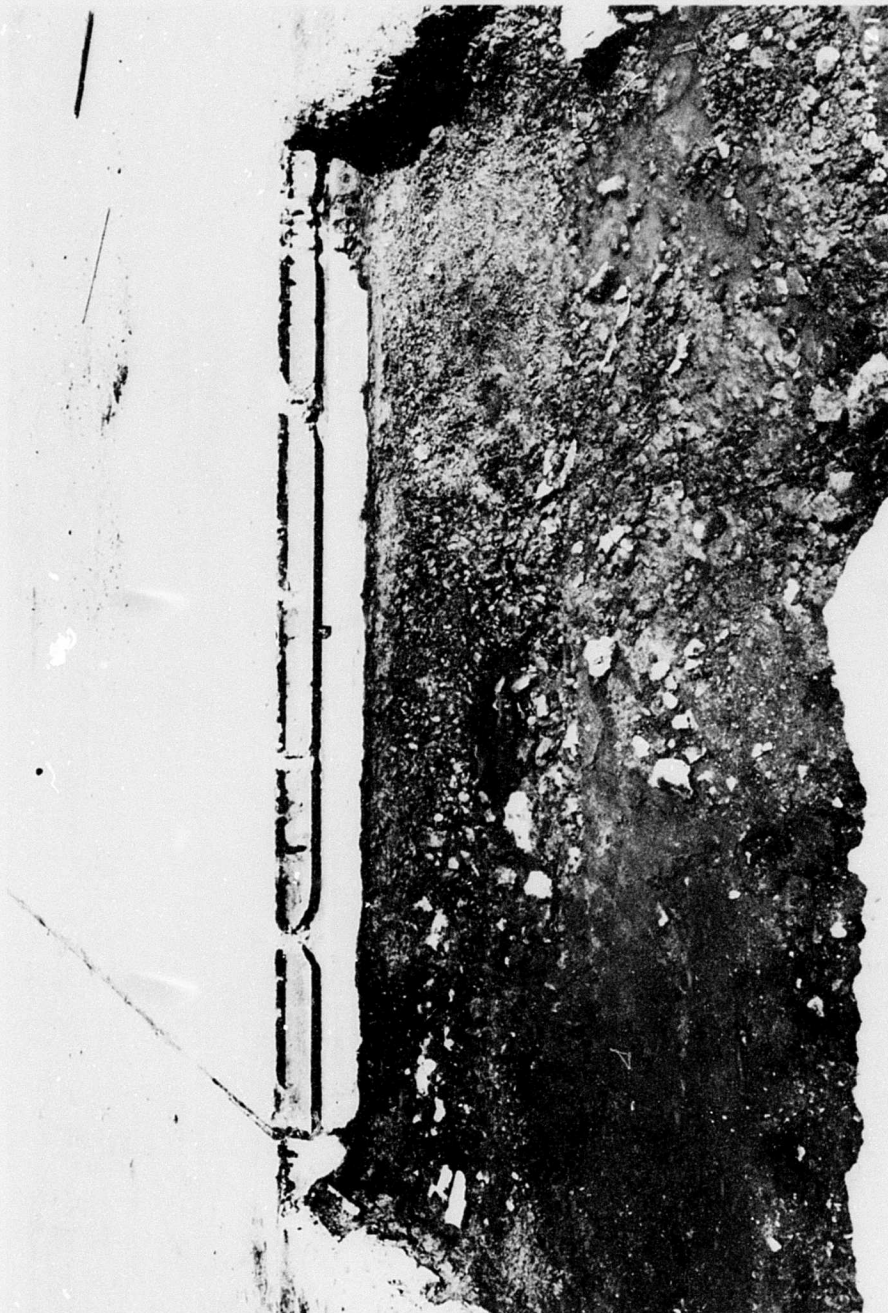
Figure 59. View of keyed longitudinal construction joint in item 4, 360-kip, 12-wheel-assembly lane after 6336 coverages.

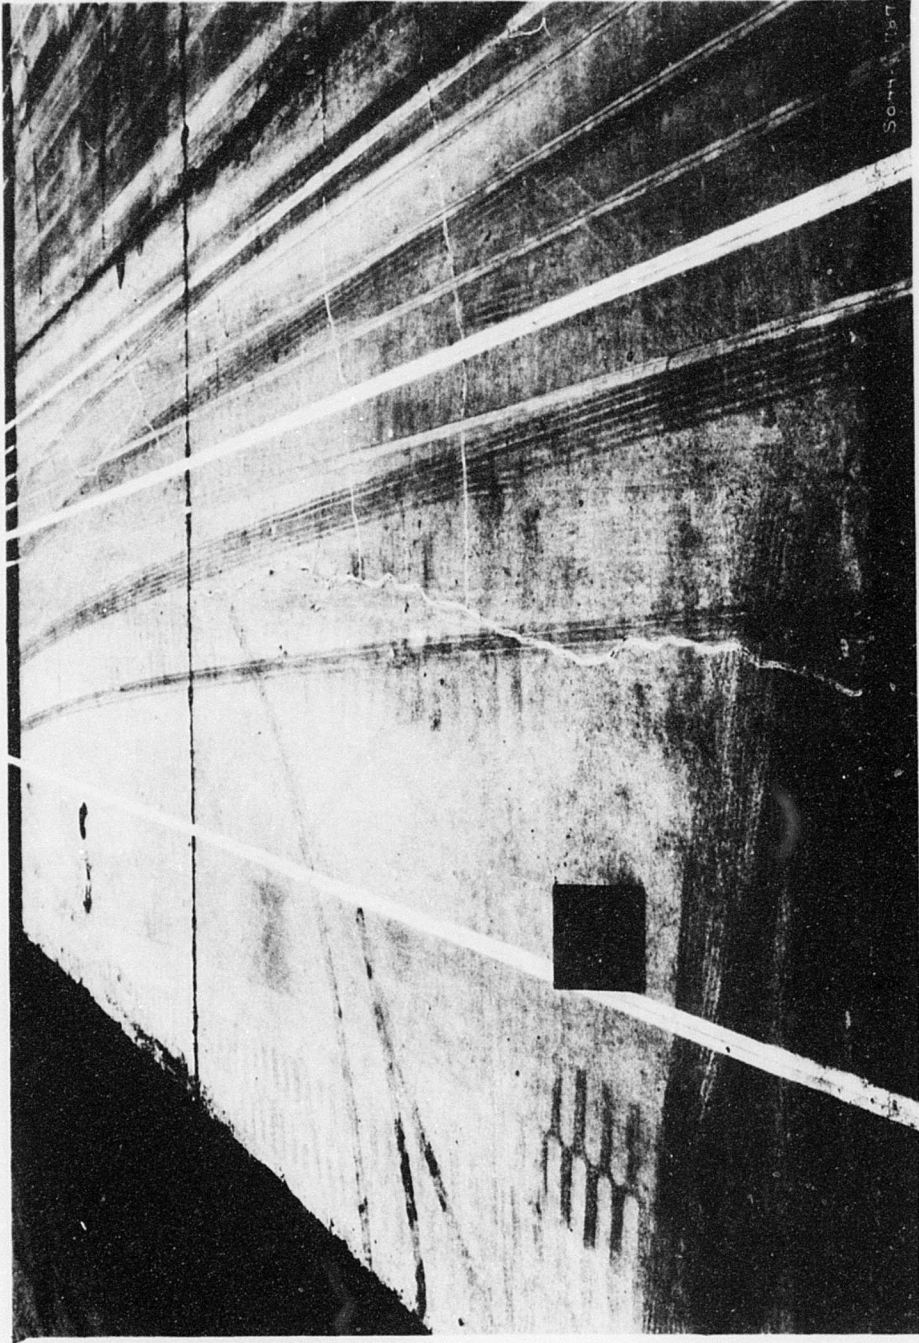
A general view of the item prior to traffic is shown in figure 60. As can be seen, both slabs contained cracks prior to traffic. The longitudinal crack in about the center of the traffic lane of the northwest slab was detected prior to the 12-wheel-assembly traffic; the remaining cracks developed during the 12-wheel-assembly traffic. When the twin-tandem traffic was commenced, pumping was observed at the existing longitudinal crack in the northwest slab. The initial crack due to traffic, a 6-ft-long longitudinal crack in the northeast slab, was detected after 4 coverages of traffic and continued to progress and extended the length of the slab after 35 coverages. After 35 coverages, several diagonal cracks and another longitudinal crack had developed in the northeast slab, and a longitudinal and several transverse cracks were observed in the northwest slab. Traffic was discontinued after 35 coverages when the item was considered to be a shattered-slab failure. A general view of the item at failure is shown in figure 61. The progression and extent of cracking during the traffic period is shown in figure 62.

Figure 60. Item 1, 166-kip, twin-tandem-assembly lane prior to traffic.

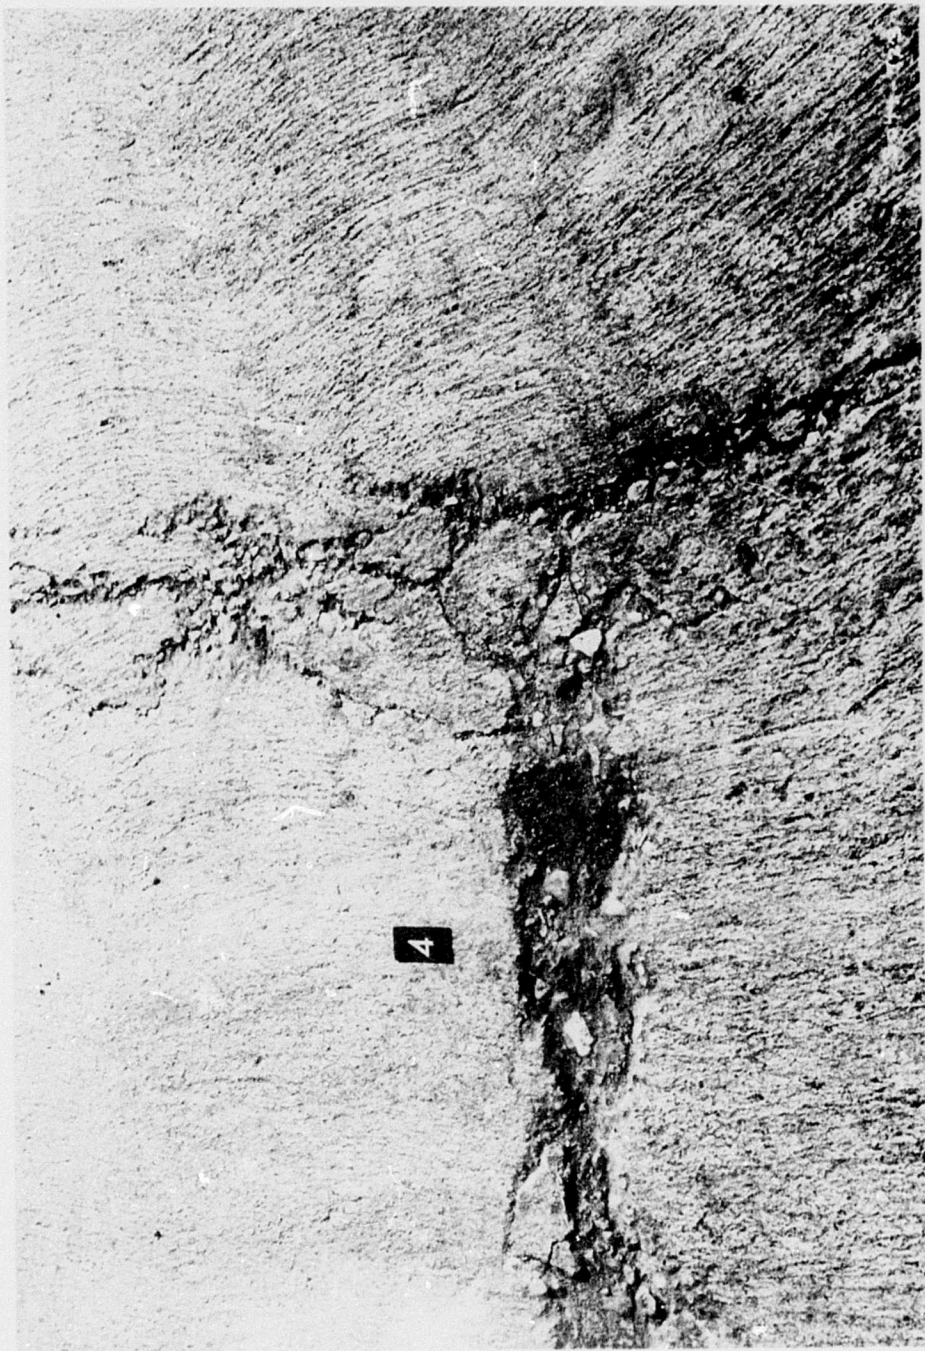
Figure 71. Spalling and flaking along the cracks in item 4, 166-kip, twin-tandem-assembly lane after 950 coverages.
